300 Industrial Blvd.
P.O. Box 1989 (75606-1989)
Longview, Texas 75602-4720
Tel: 903 758-9981**Tech Tip #24****Sentinel Drive Axle Vents**

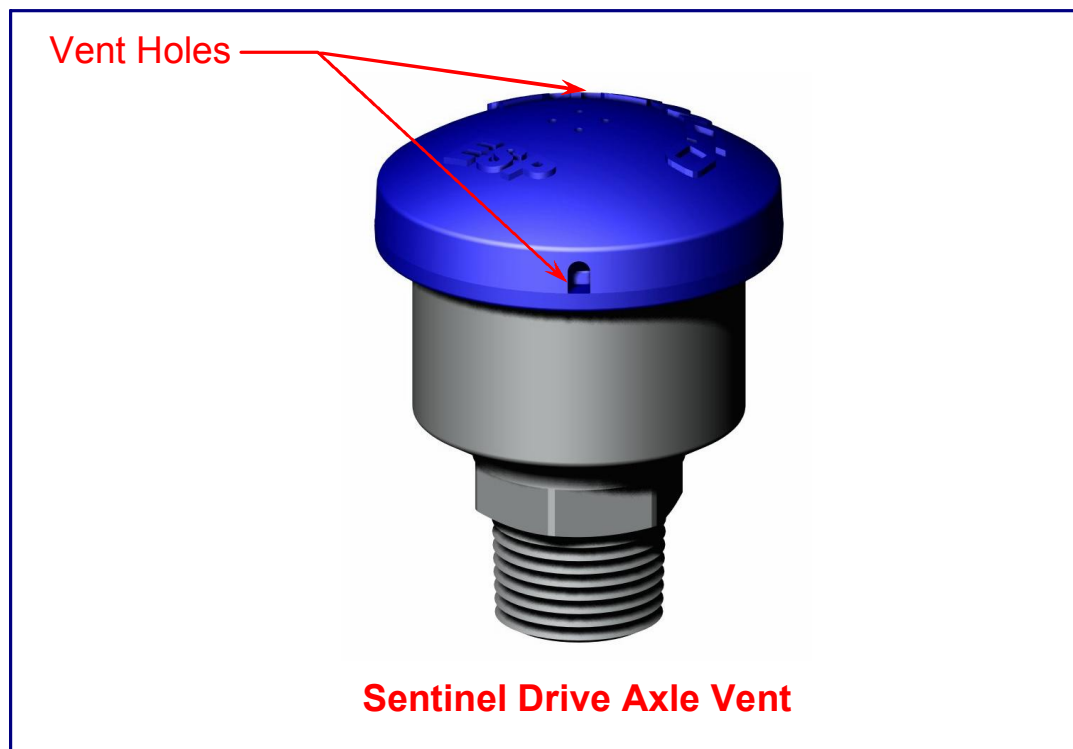
The venting performance of the Sentinel Drive Axle Vent may be compromised by extreme conditions in off-road applications. High levels of dust, dirt, or other contaminants combined with mud or road spray produced by the vehicle during operation has in some cases clogged the vent holes of the ESP assembly (see Photo below).

The Sentinel Drive Axle Vent product was designed to exclude water and contamination under normal operating conditions such as over-the-road fleet haul and urban delivery. Therefore, Stemco recommends that the Drive Axle Vent product be used only under these circumstances.

As with any drive axle venting device, it is highly recommended that fleets periodically inspect the units for damage or other failures related to the operating environment. Drivers should visually check the vent along with lubricant levels, etc. at each vehicle pre-trip inspection. This type of preventative maintenance will help insure maximum performance of the vehicle's drive train.
